## Now You See It, Now You Don't

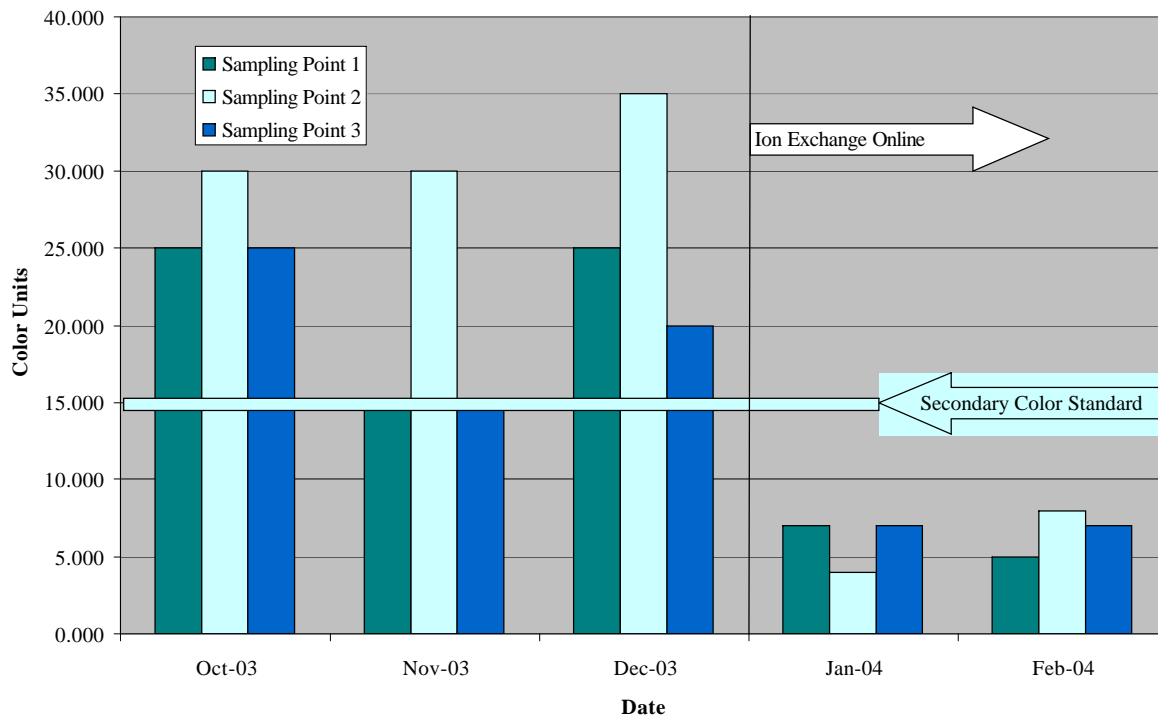
**Water Color Measurements  
Before and After Ion Exchange Treatment**

The results have been 'clearly' visible. The monitoring shows removal of over 95% of the iron and manganese, and stains on fixtures are disappearing. The removal of the iron and manganese has had an immediate effect on the color of the water. The EPS Secondary Drinking Water Standard for color is 15. The facility is now meeting a newly established internal color standard of 5 in the drinking water tank, which is 3 times more 'clear' than the secondary standard. Currently, work is underway to optimize the system.
